# Inspection Report

**Property Address:**  
333 Wild Raspberry Lane  
Etowah NC

**HomeBuyers Inspection HBI**

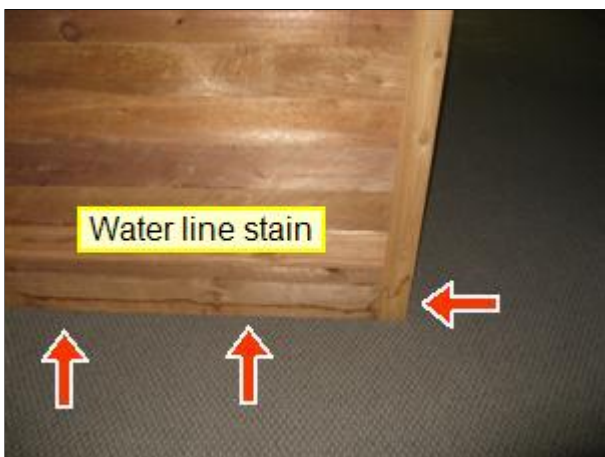
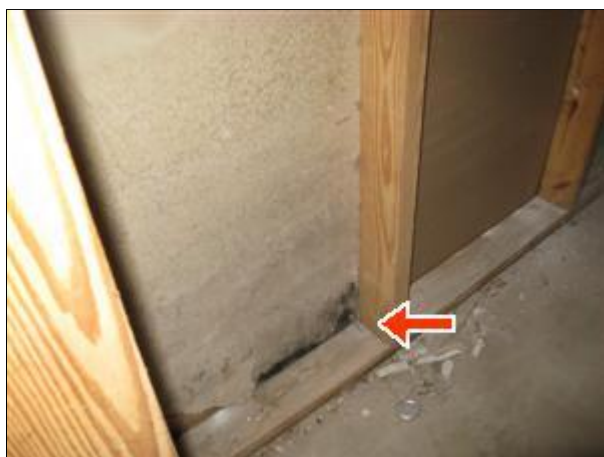
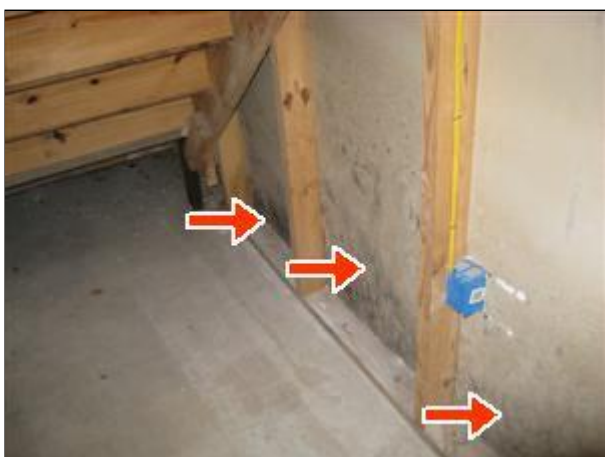
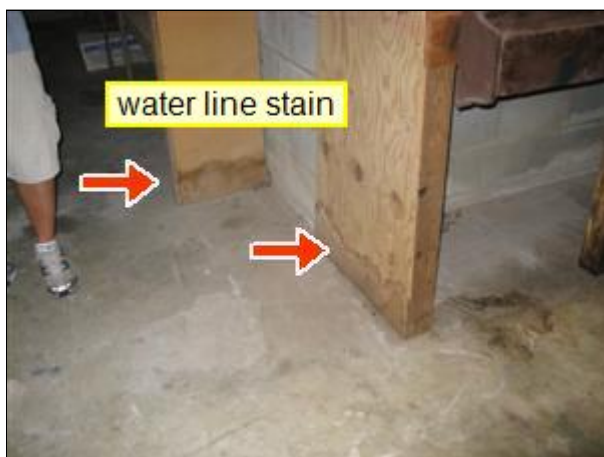
- 🔍 (1) White efflorescence (powder substance) on block wall indicates moisture is in contact with the masonry. This does not necessarily indicate that intrusion will occur. I recommend checking the gutters and the downspout drain lines for proper operation. Also, a water proofing paint could be applied to the interior side of the block if necessary. Efflorescence is found on many homes without water intrusion occurring inside the home. But, it should alert you to the possibility that future steps may be needed.
- 🔍 (2) Water signs on cedar wall and trim. Also a mold like substance on carpet at lower level and under stairs. I did not inspect or test for mold and I am unable to determine if water intrusion occurs.

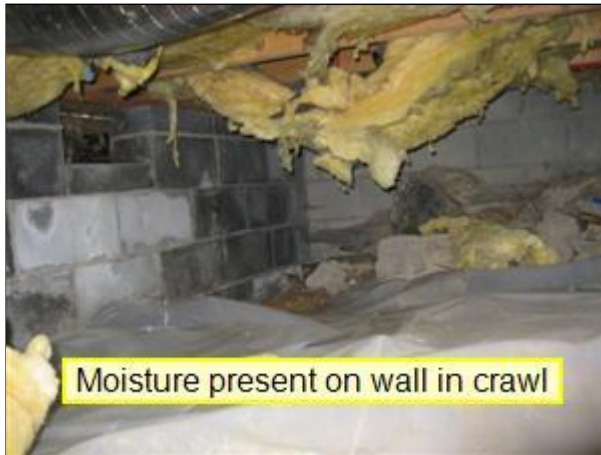
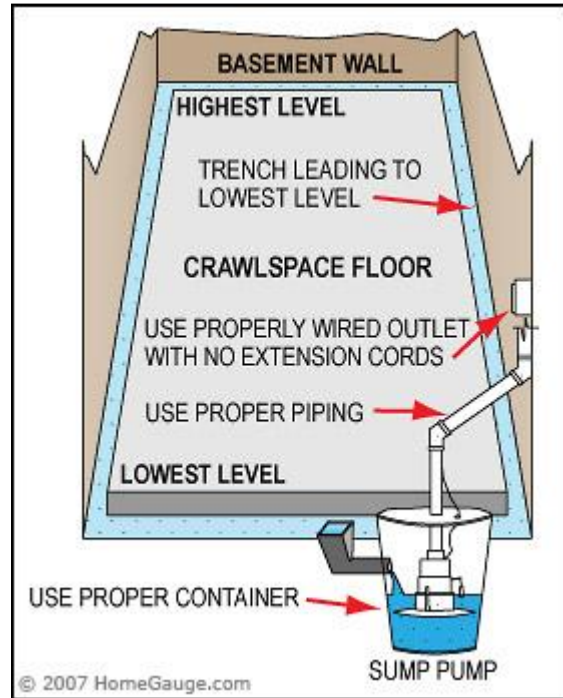
1.0 Picture 5 crawlspace under kitchen

🔍 (3) Visible signs of water intrusion in the crawlspace (along front of home) are present from dampness along the block wall. I am unable to determine the extent of intrusion or how often it occurs. Cross ventilation may help as the crawls has no ventilation. I recommend further investigation or correction by a qualified licensed contractor or water infiltration specialist. Refer to the diagram as a guide if a drainage system is needed.

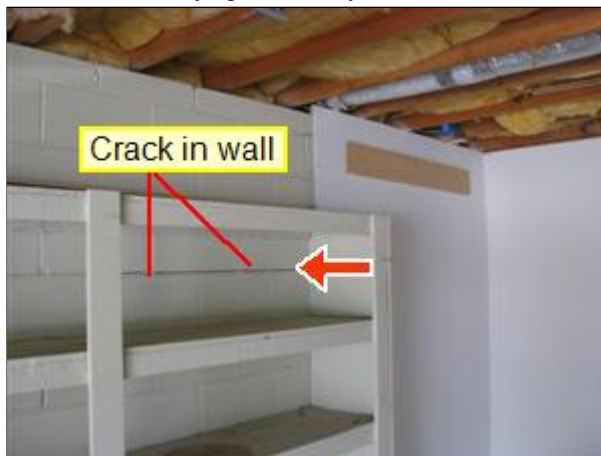
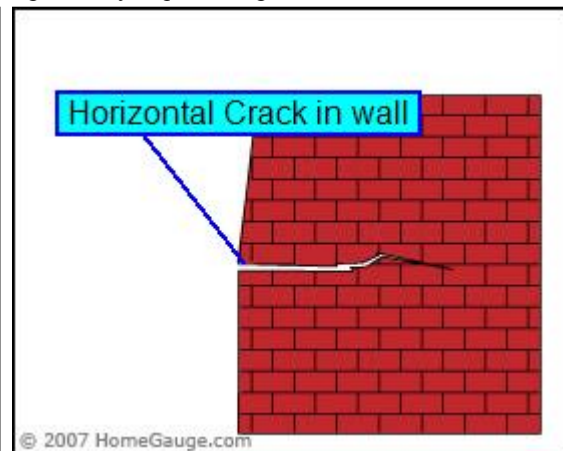
1.1 Picture 1

🔍 There is a horizontal crack(s) in the foundation wall at the left side (facing front). These cracks do not appear significant to require repairs at this time. This is my opinion and you should seek a second opinion by a qualified person.

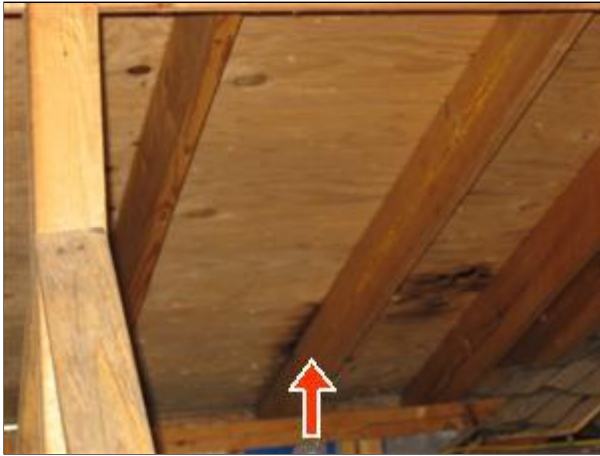
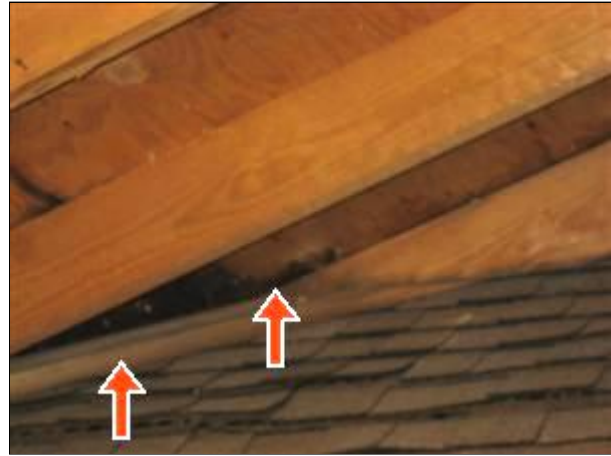
1.5 Picture 1

- 🔍 Leak signs in attic perhaps or likely from the *old roof* as this newer roof appears in tact. I am unable to determine if leak exists due to no recent rain.

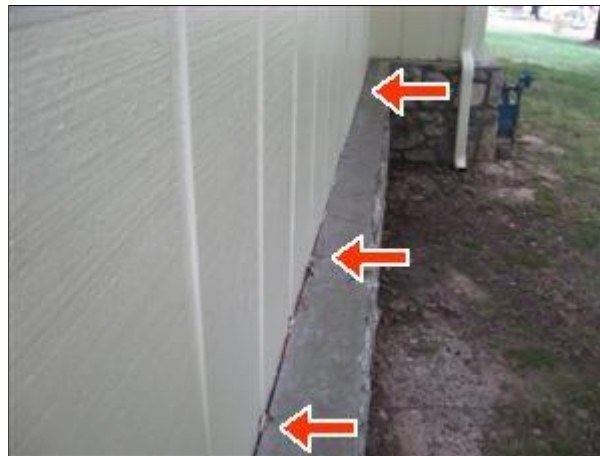
2.0 Picture 1

Periodical maintenance caulking needed and recommended to keep water from weeping under siding at concrete shelf. FYI

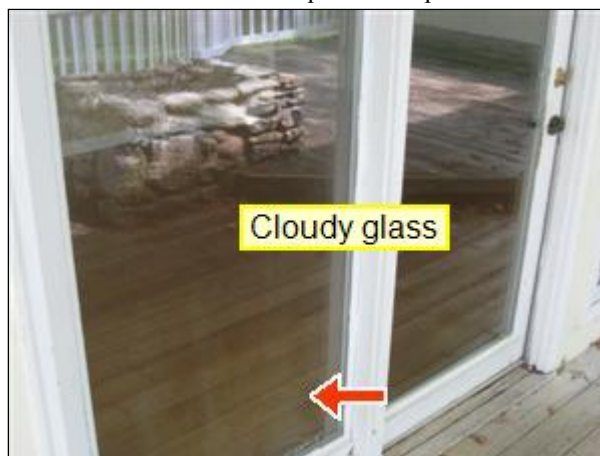
2.1 Picture 1

- 🔨 Patio doors at rear of home are cloudy or seal is broken. Glass panes that have lost their seal (cloudy) can usually be replaced without replacing the entire unit. A qualified contractor should inspect and repair as needed.

Patio doors at rear of home are cloudy or seal is broken. Glass panes that have lost their seal (cloudy) can usually be replaced without replacing the entire unit. A qualified contractor should inspect and repair as needed.

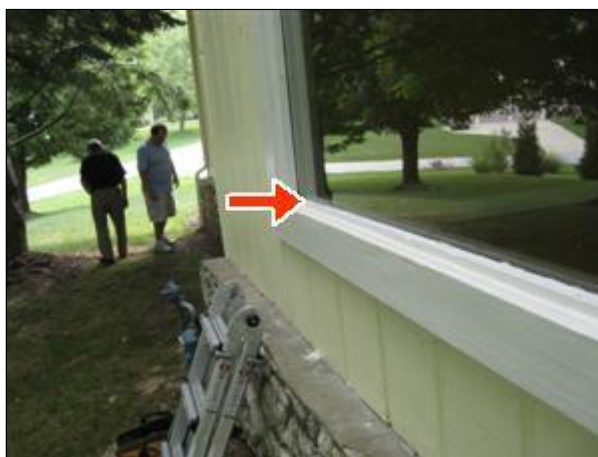
2.2 Picture 1

- 🔨 The trim stop for fixed pane is weathered and indicates that water may be getting below trim. I recommend a paintable sealant be applied and paint trim.

The trim stop for fixed pane is weathered and indicates that water may be getting below trim. I recommend a paintable sealant be applied and paint trim.

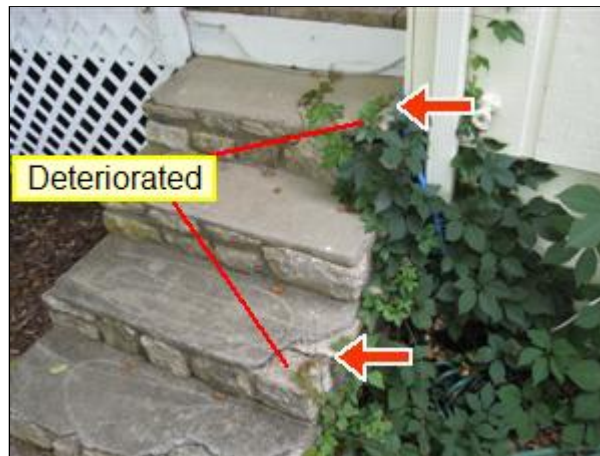
2.3 Picture 1

- 🔨 (1) The step tread on steps on the deck at the rear of home are deteriorated. A repair or replacement is needed. A skilled masonry contractor should perform the work.

A handrail may be needed

(1) The step tread on steps on the deck at the rear of home are deteriorated. A repair or replacement is needed. A skilled masonry contractor should perform the work.

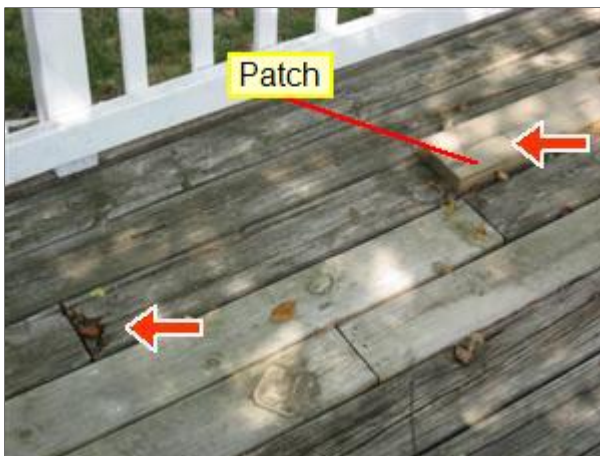
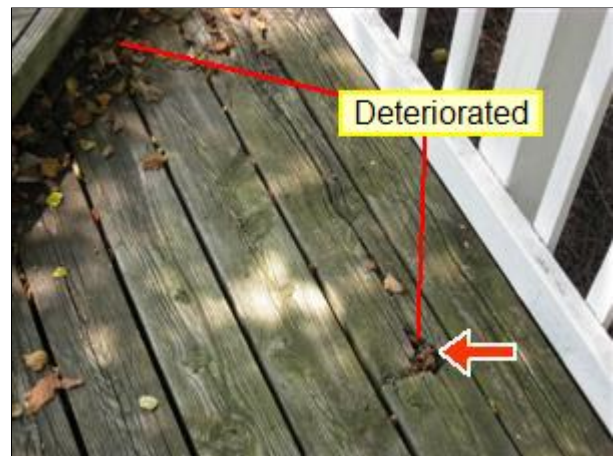
2.3 Picture 2

(2) The 2x6 decking on the deck at the rear of home has several boards that are deteriorated. A general replacement is likely. A qualified contractor should determine whether a repair or replacement is needed.

(2) The 2x6 decking on the deck at the rear of home has several boards that are deteriorated. A general replacement is likely. A qualified contractor should determine whether a repair or replacement is needed.

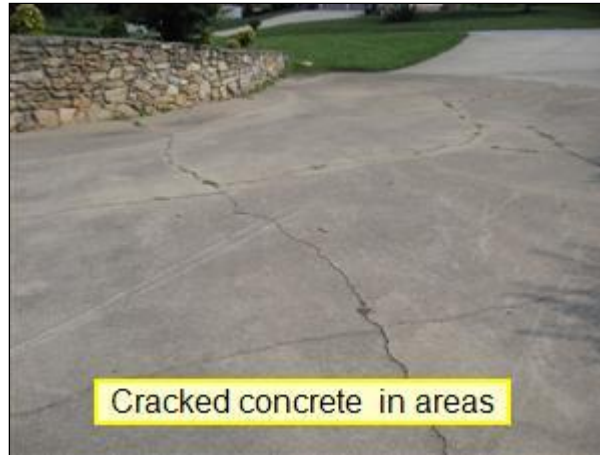
2.4 Picture 1

🔨 The concrete drive at the front of home is pitted in areas and has settlement cracks. Further deterioration can occur if not repaired. A qualified contractor should inspect and repair as needed.

- The concrete drive at the front of home is pitted in areas and has settlement cracks. Further deterioration can occur if not repaired. A qualified contractor should inspect and repair as needed.

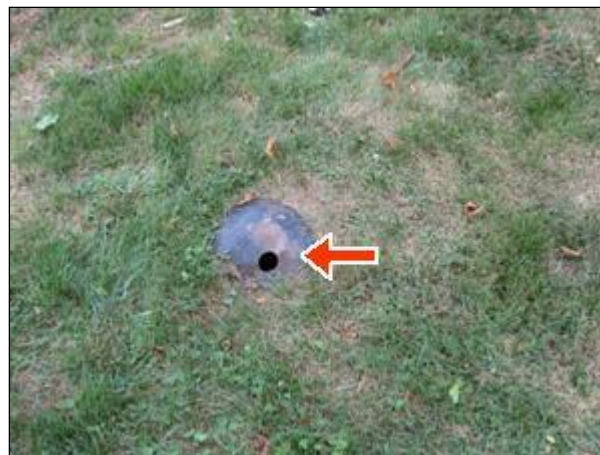
2.6 Picture 1

🔍 (1) Old propane tank in ground and is discontinued. I did not determine if gas remains in discontinued tank? I recommend further investigation by a qualified person.

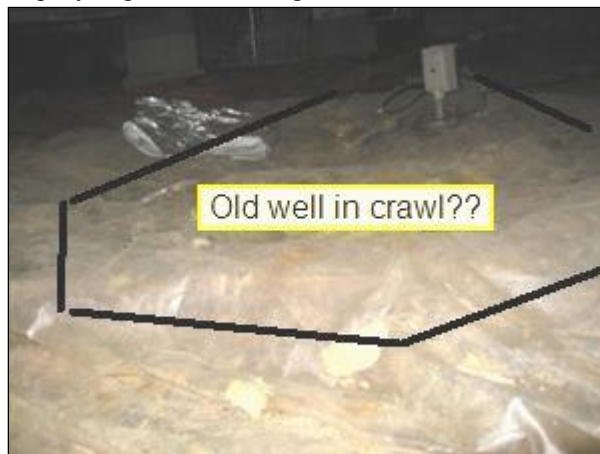
- 🔍 (2) There is an odd configuration in ground under addition in crawlspace. This may be an old well? I am unable to determine. I recommend a qualified well drilling company or plumber investigate further to determine if any further action is needed to correct.

2.6 Picture 2 in crawlspace under new addition

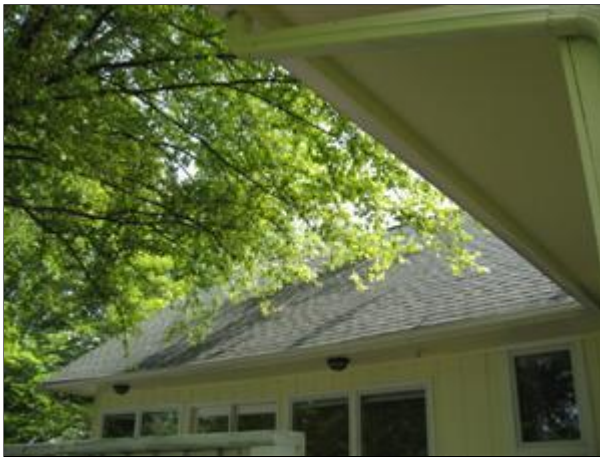
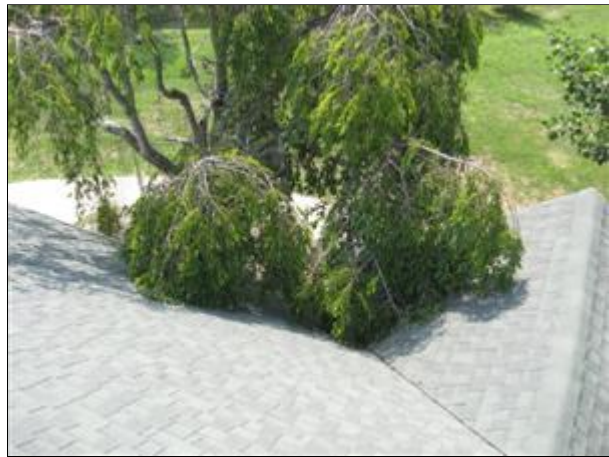
(1) The tree limbs that are in contact with roof or hanging near roof should be trimmed.

3.0 Picture 1 Rear of home

- (1) The tree limbs that are in contact with roof or hanging near roof should be trimmed.
- (2) Shingles loose under eave at front of home, needs adhesive.

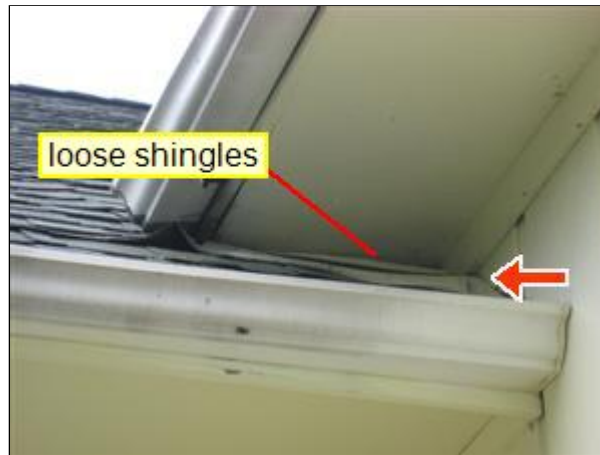
3.0 Picture 3

(2) Shingles loose under eave at front of home, needs adhesive.

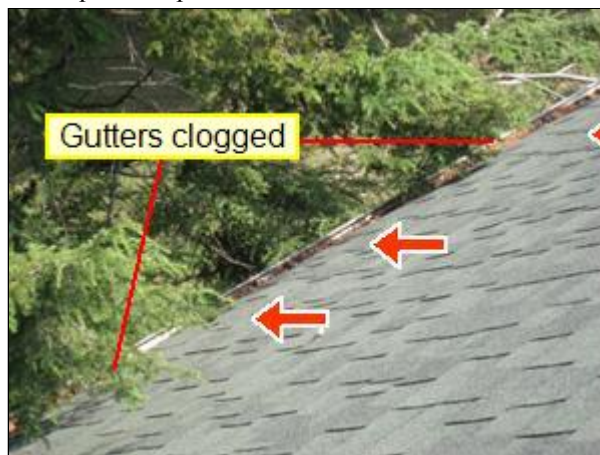
3.3 Picture 1

- 🔧 The gutter needs cleaning of debris at the virtually all areas where gutters are installed. Gutters that drain poorly or clogged can lead to many costly problems such as deterioration of fascia, soffit or roof edge. It can also cause gutters to pull loose and lead to possible water intrusion. A qualified person should repair or replace as needed.

- The gutter needs cleaning of debris at the virtually all areas where gutters are installed. Gutters that drain poorly or clogged can lead to many costly problems such as deterioration of fascia, soffit or roof edge. It can also cause gutters to pull loose and lead to possible water intrusion. A qualified person should repair or replace as needed.

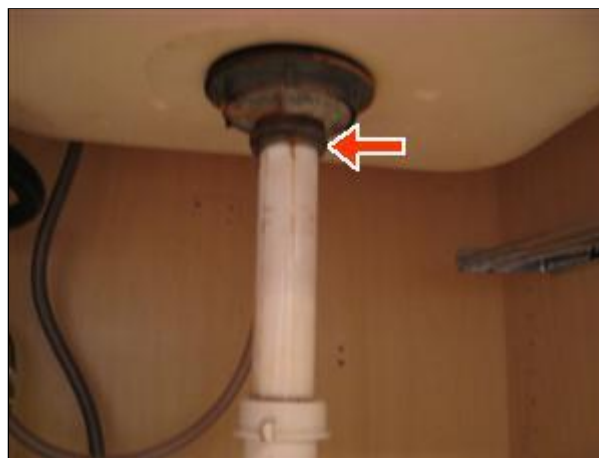
- 🔧 (1) The basket strainer had leaked and corrected itself for the time being at the Kitchen sink. Repairs are needed. A qualified person should repair as necessary.

4.0 Picture 1 Right sink basin

- (1) The basket strainer had leaked and corrected itself for the time being at the Kitchen sink. Repairs are needed. A qualified person should repair as necessary.
- (2) The tub drain drains slowly under the hall bath. Repairs are needed. A qualified person should repair as necessary.

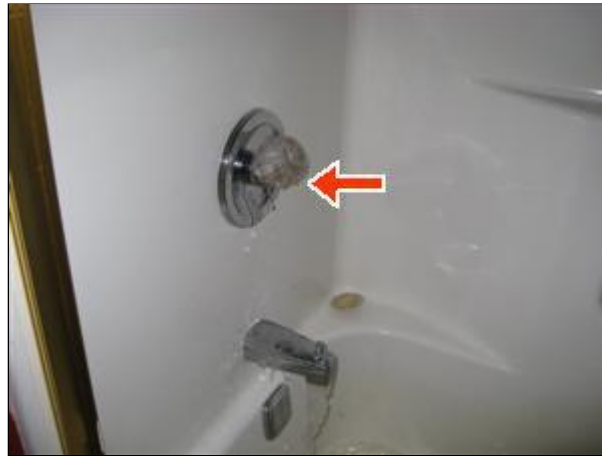
- 🔧 (1) The control knob leaks at the hall bath. Repairs are needed. A qualified licensed plumber should repair or correct as needed.

4.1 Picture 1 hall bath

- (1) The control knob leaks at the hall bath. Repairs are needed. A qualified licensed plumber should repair or correct as needed.
- (3) I recommend the well head lid be insulated better before winter. FYI

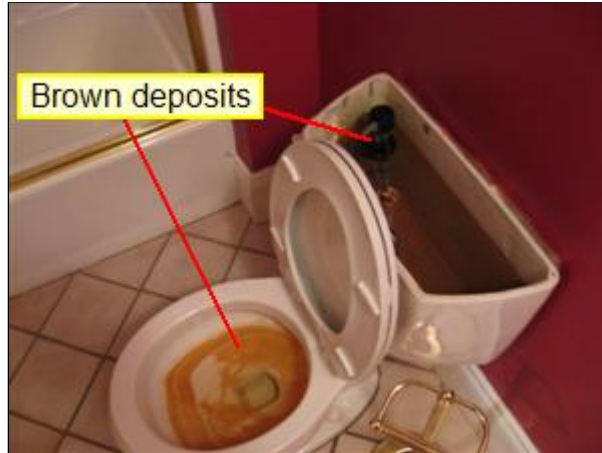
4.1 Picture 2

- 🔍 (2) Brown deposits are on the plumbing fixtures which indicates a filter may be needed. Filter in place and appears dirty but I am unable to determine if you need a different or additional filter. I did not test water for bacteria or other. I recommend contacting a water filtration company.

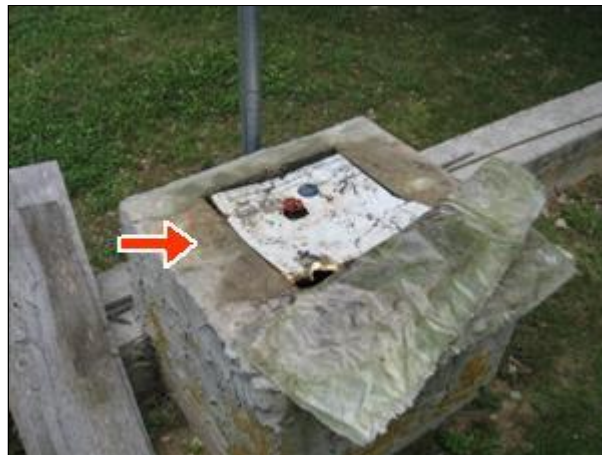
- 🔧 (3) I recommend the well head lid be insulated better before winter. FYI

4.1 Picture 3 Well head

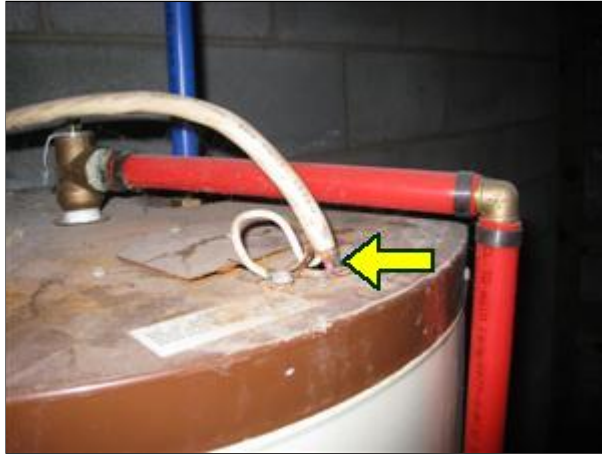
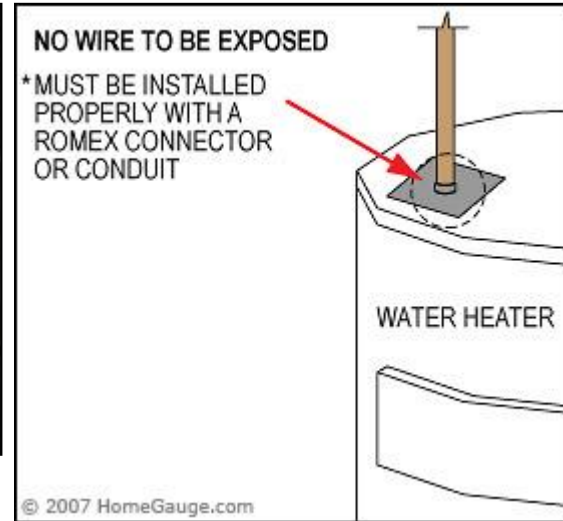
4.2 Picture 1

- 🔧 The wiring for the water heater missing romex connector. Electrical issues are considered a hazard until repaired. I recommend a licensed electrician correct as necessary.

- The wiring for the water heater missing romex connector. Electrical issues are considered a hazard until repaired. I recommend a licensed electrician correct as necessary.

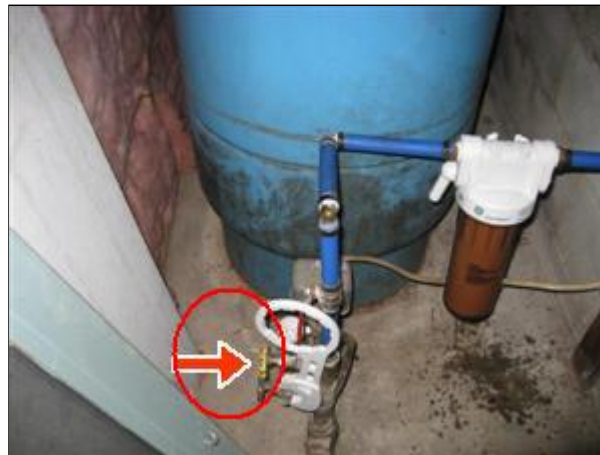
The main shut off is the yellow knob located in the basement at the pressure tank. This is for your information.

4.3 Picture 1 In basement

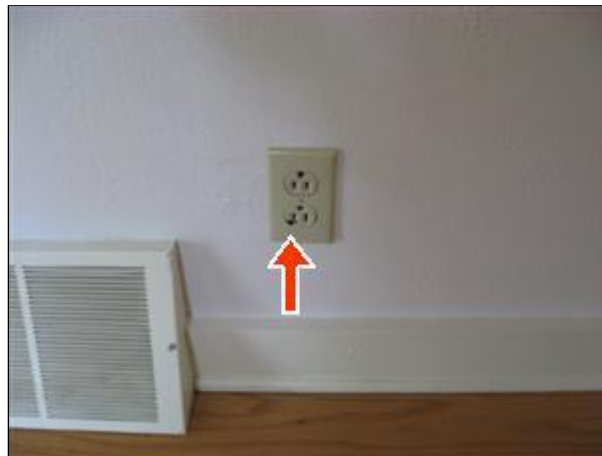
5.3 Picture 1

- 🔧 (1) The wall switch is broken (unsafe) at the upstairs closet for air handler. At least two outlets are broken at LR and entry way. Electrical issues are considered a hazard until repaired. A qualified licensed electrician should perform repairs that involve wiring.

(1) The wall switch is broken (unsafe) at the upstairs closet for air handler. At least two outlets are broken at LR and entry way. Electrical issues are considered a hazard until repaired. A qualified licensed electrician should perform repairs that involve wiring.

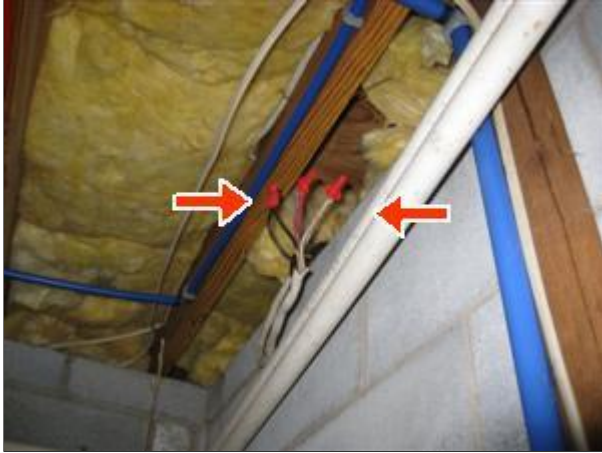
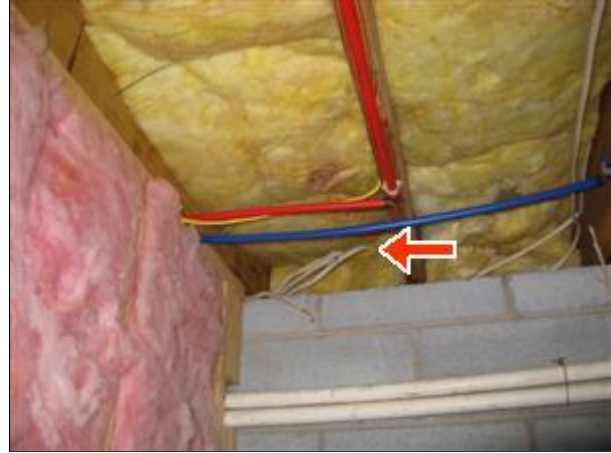
5.3 Picture 2

- (2) Several loose wire ends needs placing inside a box with a cover-plate in the basement at the pressure tank of well. I recommend repair as needed.

(2) Several loose wire ends needs placing inside a box with a cover-plate in the basement at the pressure tank of well. I recommend repair as needed.

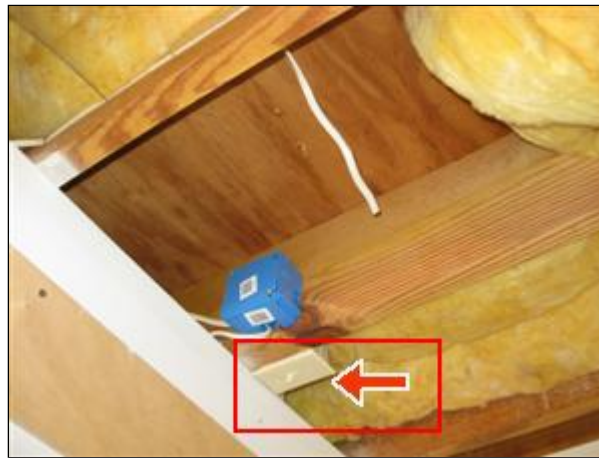
5.3 Picture 4

- (3) Wall switch on ceiling in Garage, purpose unknown

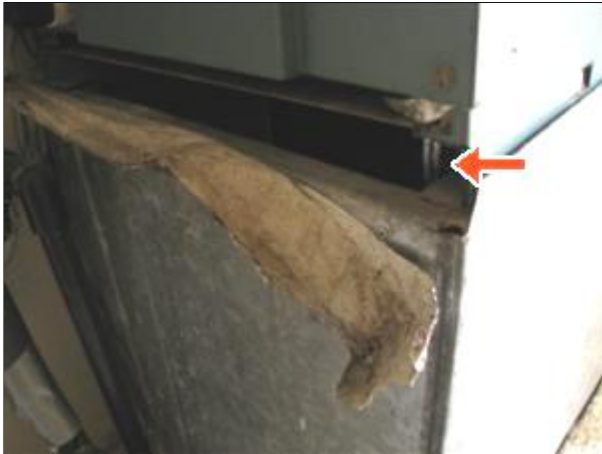
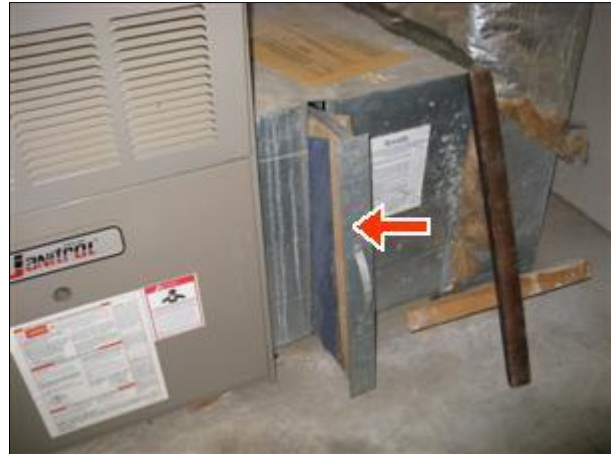
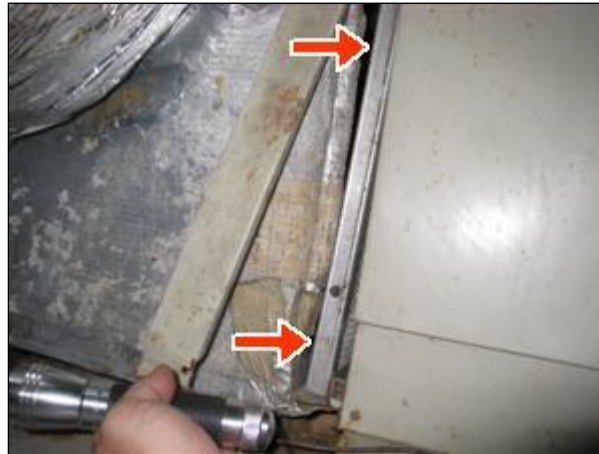
- 🔧 (1) The washable filter is collapsed and needs replacing at upstairs. The filter needs replacing with a rigid frame to prevent filter from falling out of alignment. ( Picture 1 ) The filter in basement ( Picture 2 ) needs replacement and in crawlspace which is difficult to access due to the crawlspace ( Picture 3 ). A qualified person should repair or replace as needed

(1) The washable filter is collapsed and needs replacing at upstairs. The filter needs replacing with a rigid frame to prevent filter from falling out of alignment. ( Picture 1 ) The filter in basement ( Picture 2 ) needs replacement and in crawlspace which is difficult to access due to the crawlspace ( Picture 3 ). A qualified person should repair or replace as needed

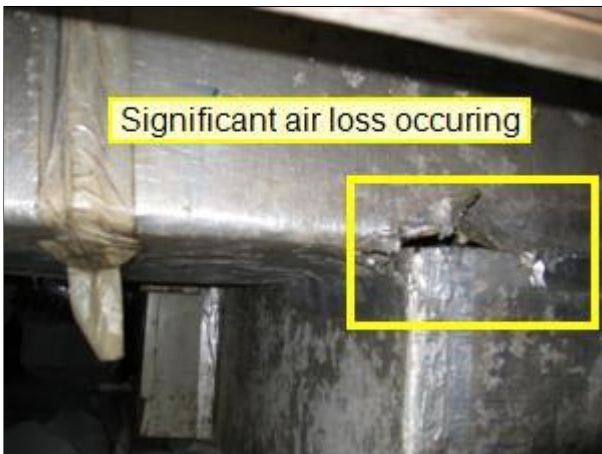
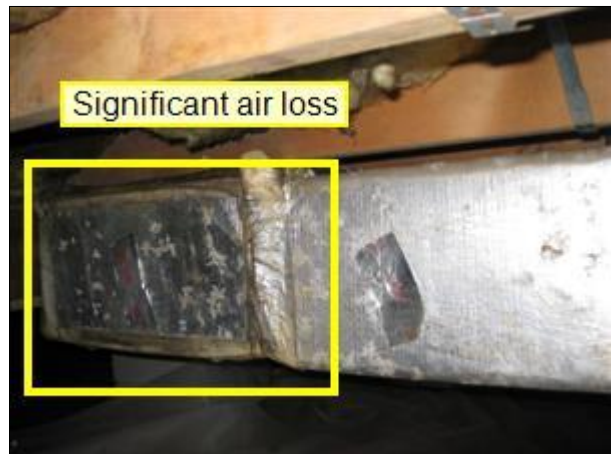
(2) The supply duct pipe or main plenum is failing in the crawlspace. Energy loss is occurring in crawlspace and immediate correction is needed. A licensed HVAC contractor should service or repair unit.

6.3 Picture 4 crawlspace new addition

(2) The supply duct pipe or main plenum is failing in the crawlspace. Energy loss is occurring in crawlspace and immediate correction is needed. A licensed HVAC contractor should service or repair unit.

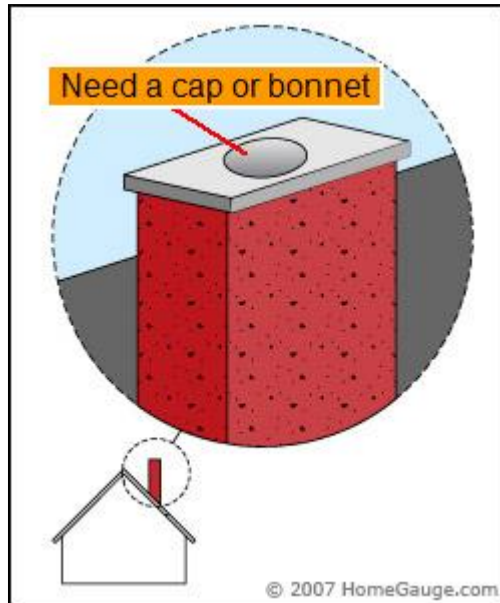
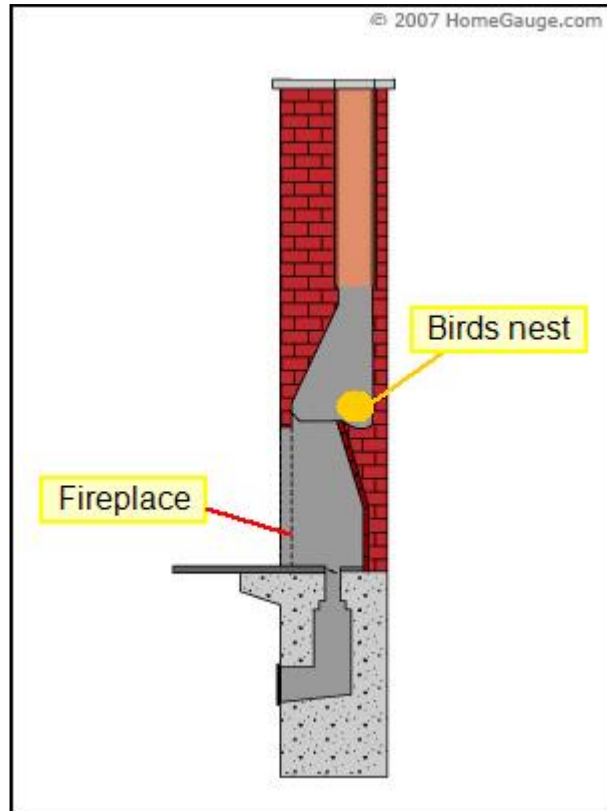
6.5 Picture 1

An active birds nest is currently in chimney. It is recommended to install a cap or bonnet on chimney this fall.

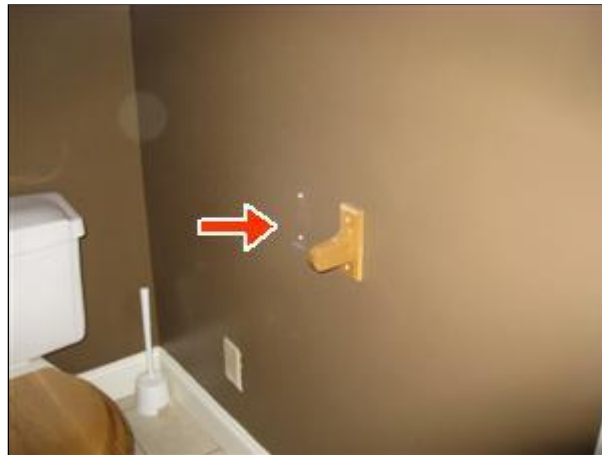
8.1 Picture 1

The tissue holder on the wall is damaged at the master bath. I recommend repair as necessary.

The tissue holder on the wall is damaged at the master bath. I recommend repair as necessary.

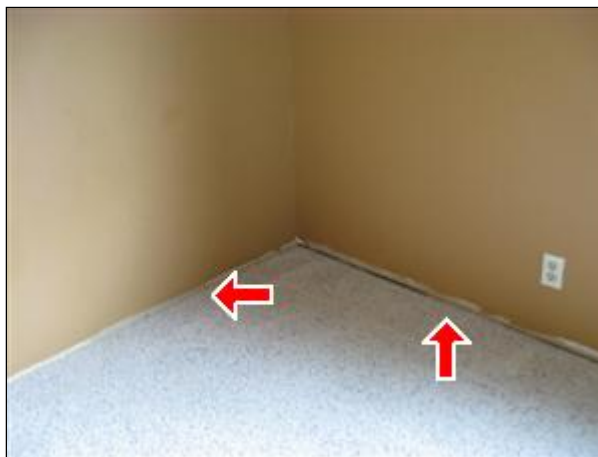
8.2 Picture 1

- 🔧 (1) The Baseboard is missing at the upstairs (right of hall bath). Repairs are needed. A qualified contractor should inspect and repair as needed.

(1) The Baseboard is missing at the upstairs (right of hall bath). Repairs are needed. A qualified contractor should inspect and repair as needed.
-

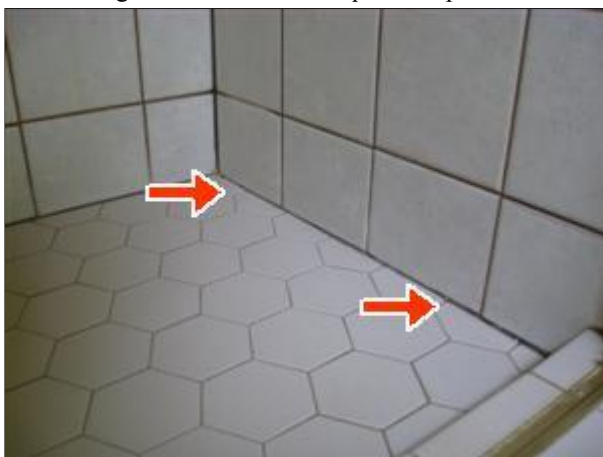
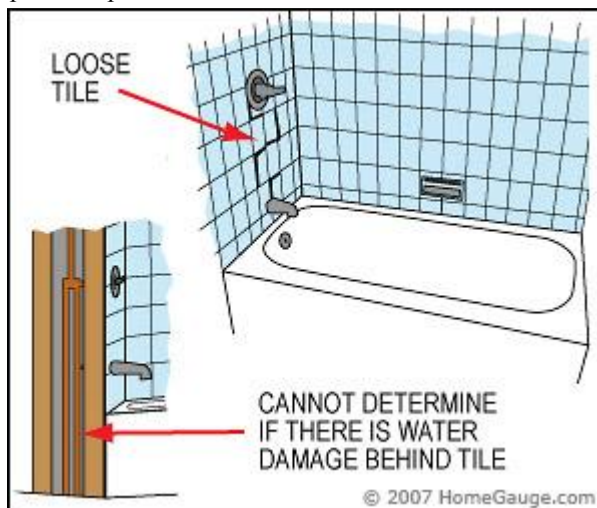
- 🔧 (2) Tile at shower pan and wall surround are loose and missing mortar or grout and sealer at the upstairs bath. Repairs are needed to prevent water damage to shower/bath. A qualified person should repair or replace as needed.

8.2 Picture 2 Upstairs bath

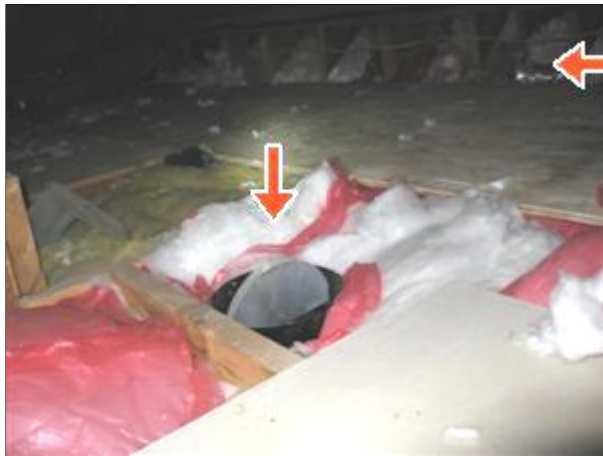
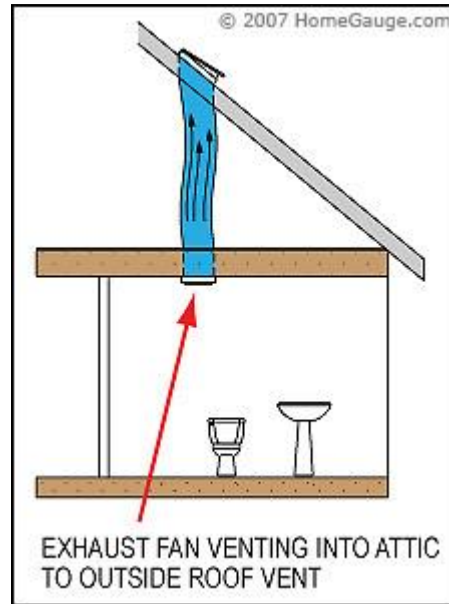
9.4 Picture 1

The Exhaust fan does not vent to outside at the hall bath and master bath. Vent pipes should terminate outside and not in the attic. Many homes have their vent pipe poised at the roof vent such as yours. It is up to you to determine whether or not this is a concern or needs further consideration from a general contractor. A qualified contractor should inspect and repair as needed.

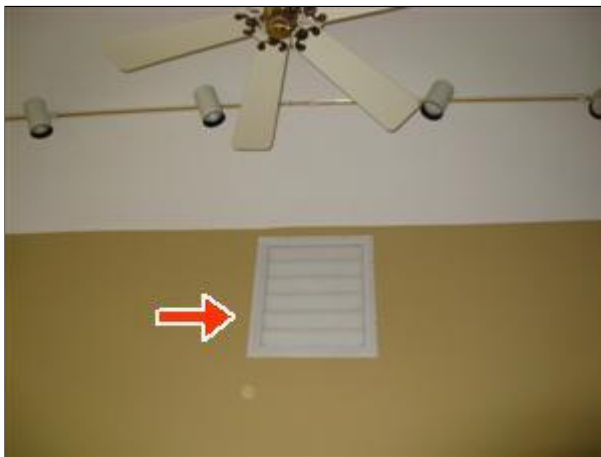
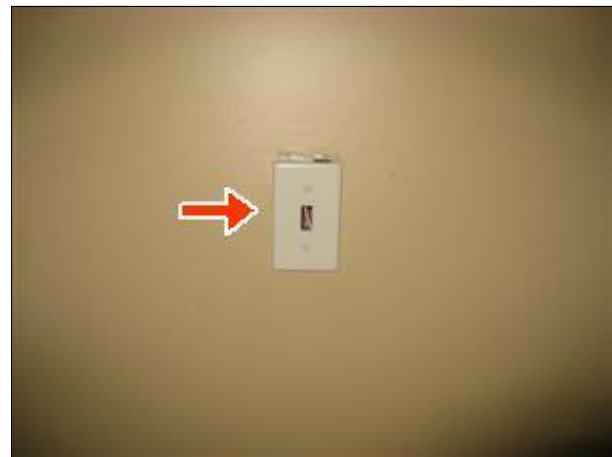
9.5 Picture 1

🔧 Wall switch for room fan in wall has been removed. It is inoperable.
